APPENDIX A. JSC PHOTOGRAPHIC ANALYSIS SUMMARY

STS-101 Summary of Significant Events

July 6, 2000

Project Work Order - SN3CS

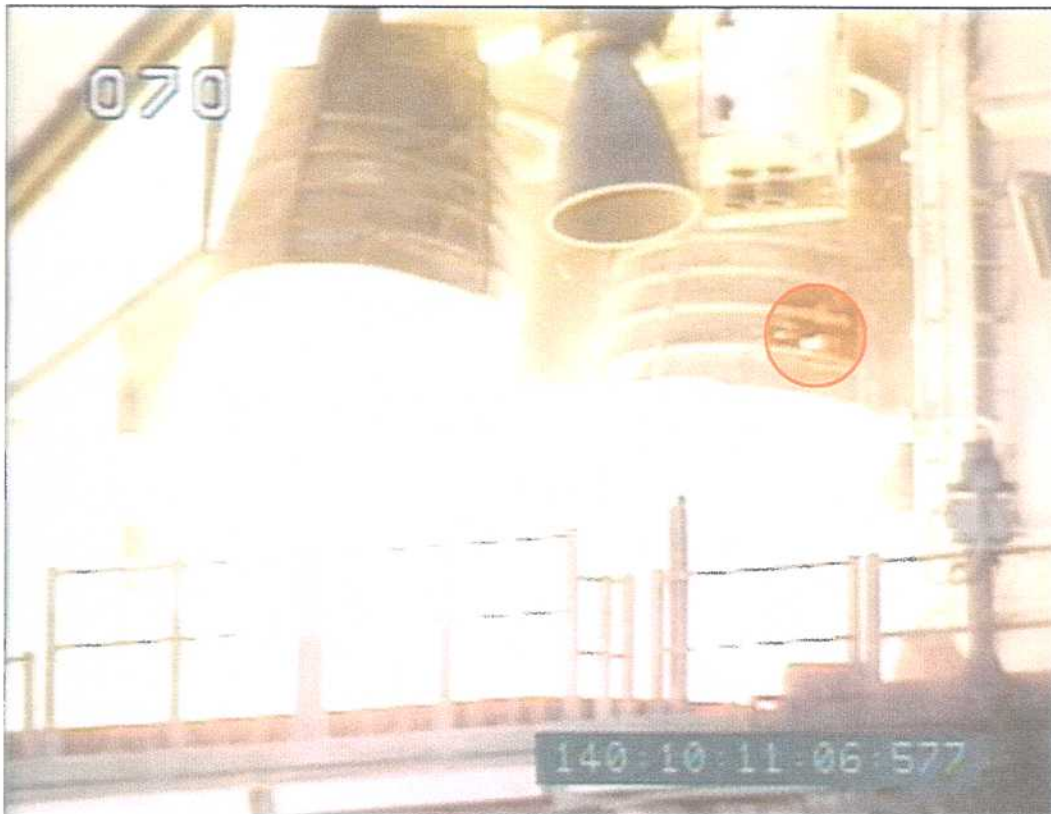
Figure 2.1(A) Ice Contacting SSME #3 Engine Bell

A large, single piece of white-colored debris (ice) from the LO2 TSM T-0 disconnect fell aft and contacted the SSME #3 engine bell at the number 8 hatband forward of the SSME #3 rim prior to the SSME Mach diamond formation (10:11:06.438 UTC). See Figure 2.1(A). A second piece of debris contacted the SSME #3 engine bell forward of the rim during SSME ignition (10:11:06.636 UTC). A large, white-colored, vaporous cloud from the LO2 TSM T-0 disconnect was seen near SSME #3 at 10:11:10.9 UTC. No damage to the SSME #3 engine bell was detected. (Cameras OTV051, OTV070, OTV071, E19, E76)

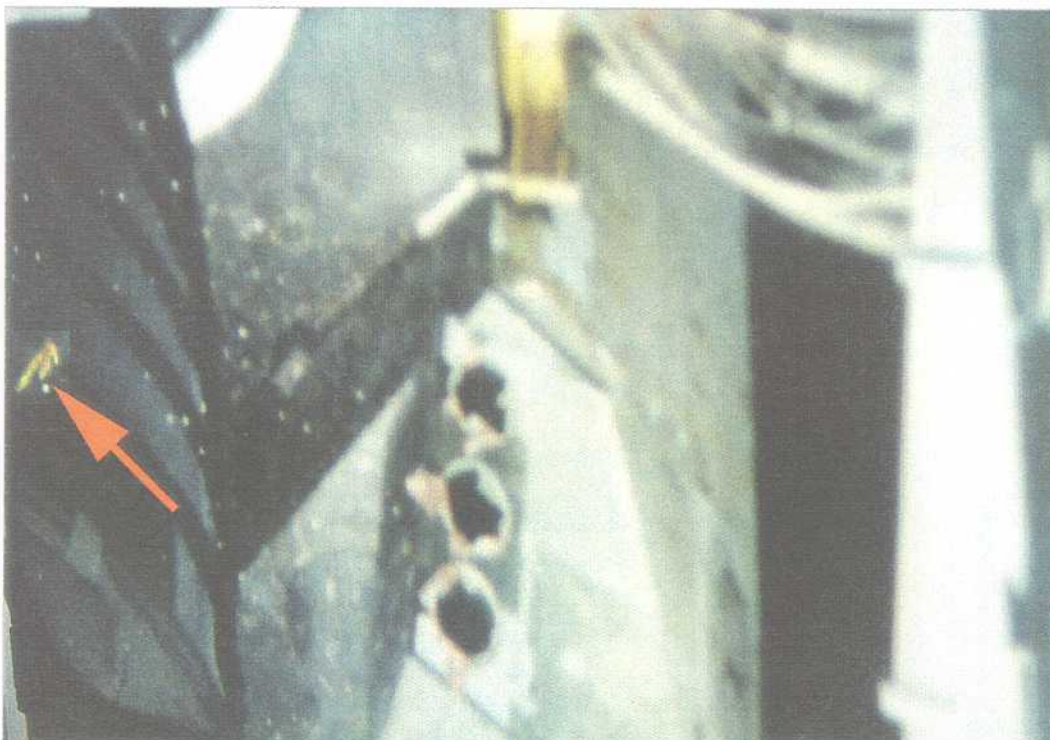
Figure 2.1(B) Orange-Colored Debris Seen after SSME Ignition

A single, orange-colored, linear-shaped, flexible appearing object (possibly a piece of umbilical purge barrier tape) fell aft along the -Z side of the body flap after SSME ignition (10:11:08.876 UTC). See Figure 2.1(B). (Camera E18)

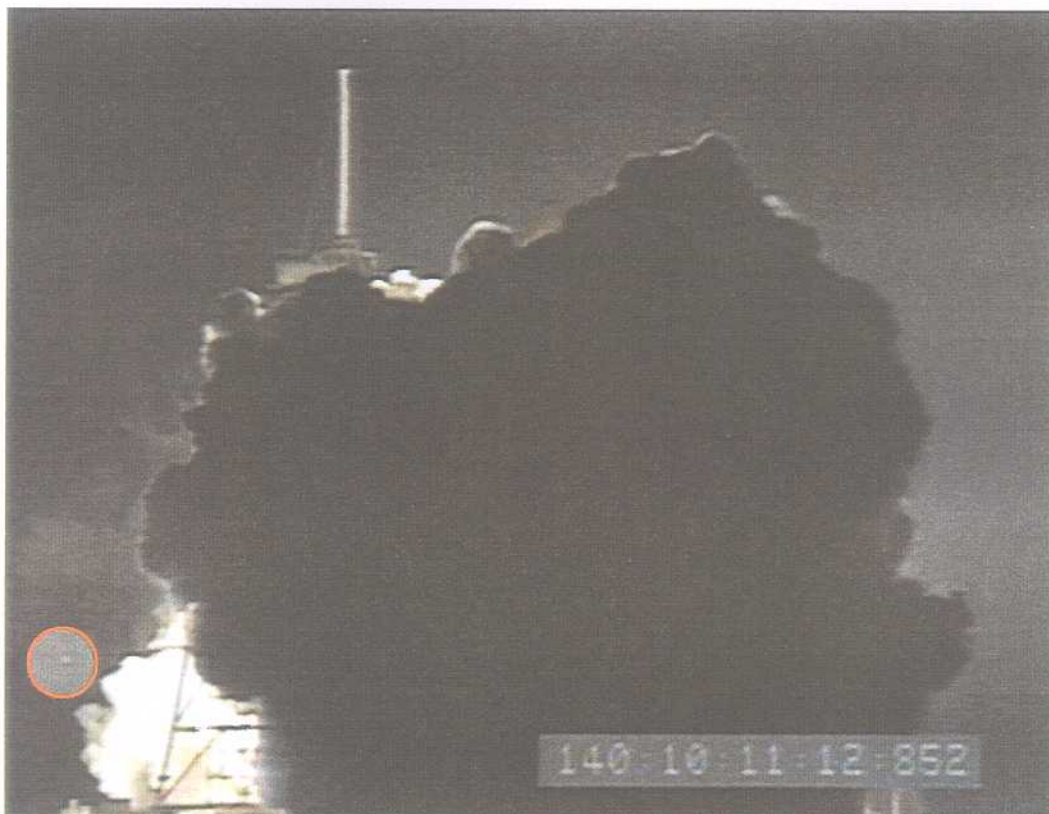
Figure 2.1(C) Debris Traveling Westward from the Launch Pad

A large light-colored rectangular-shaped piece of debris was seen during liftoff traveling westward from the launch pad. See Figure 2.1(C). KSC reported that the debris might be a panel from the RSS. This debris did not appear to be in close proximity to the launch vehicle. (Camera KTV21A)

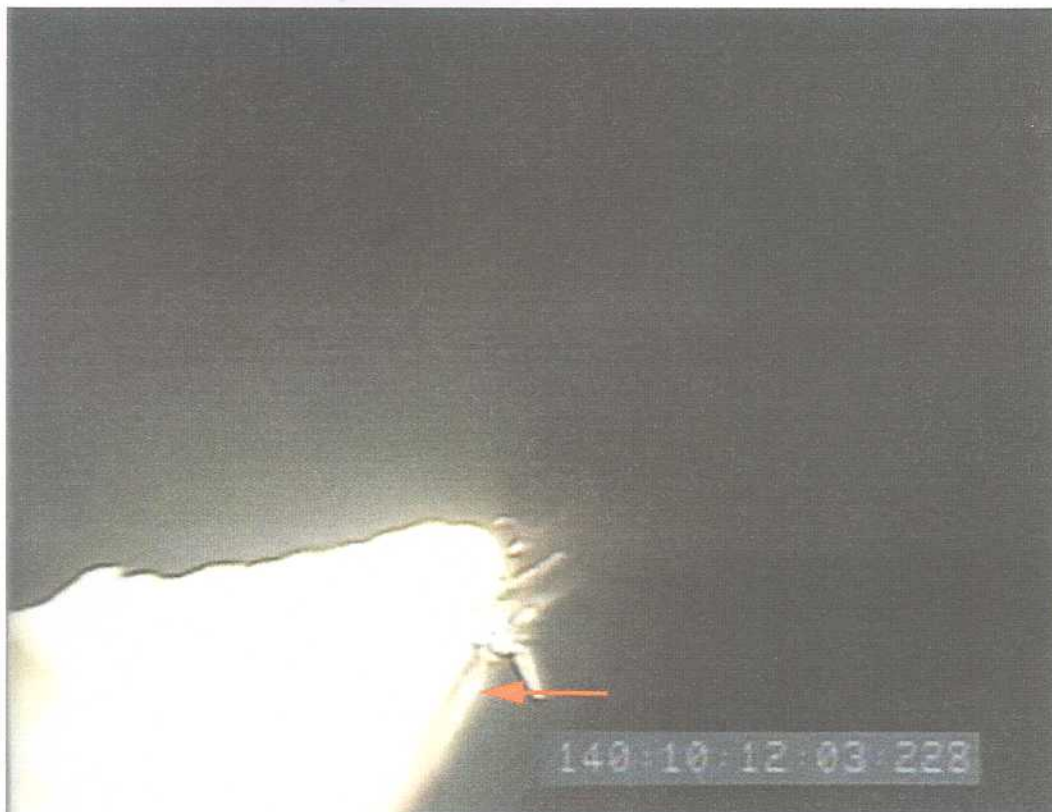
Figure 2.2(A) Flare Seen in SSME Exhaust Plume

paper debris, first seen near the right OMS pod, fell aft producing a flare in the SSME exhaust plume.

A piece of RCS paper debris was seen falling from a region near the left RCS stinger, moving across the +Z side of SSME #1, past the -X side of SSME #2, and traveling aft into the SSME exhaust plume resulting in a large orange-colored debris-induced flare (10:12:03.2 UTC). See Figure 2.2(A). Other smaller flares in the SSME exhaust plume (probably debris induced) were also seen during ascent (10:11:46.4, 10:11:54.2 UTC). Furthermore, debris was seen near the SRB exhaust plume during ascent (10:11:11.35, 10:11:45.2, 10:12:13.9, 10:12:23.5, 10:12:24.2, 10:12:26.9 UTC). (Cameras KTV2, KTV5, KTV4A, ET207, ET212, ET213, E52, E207, E212, E222, E223, E224)

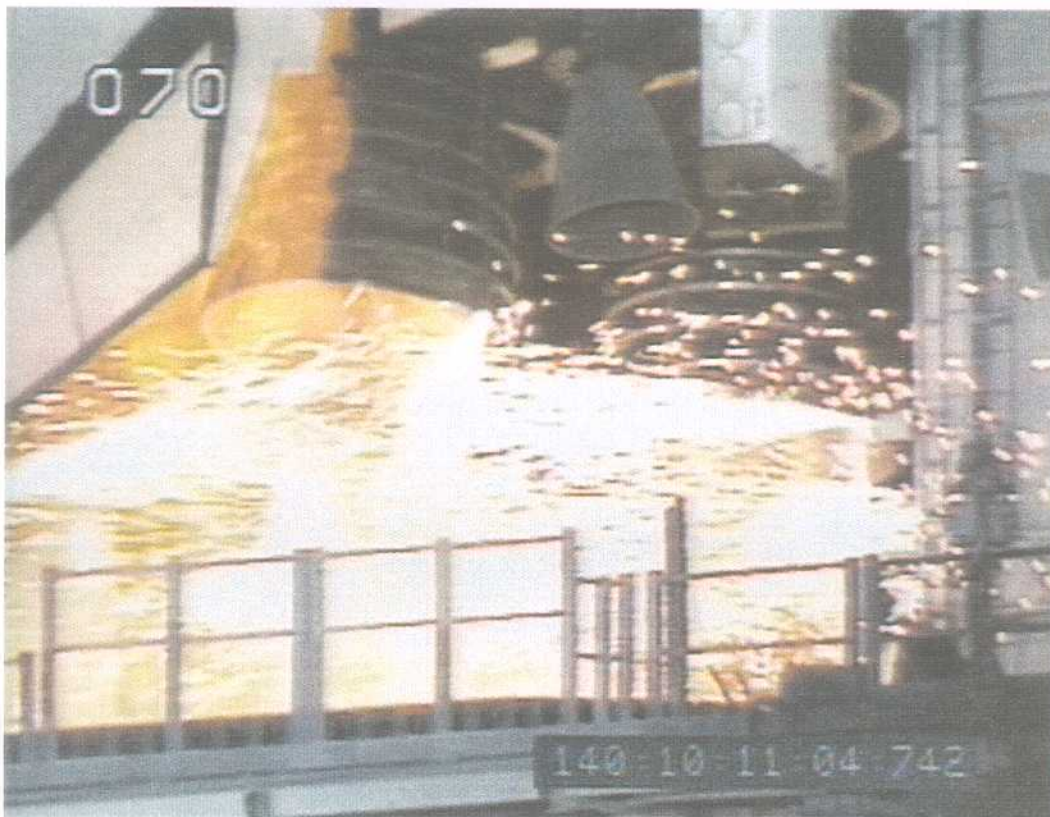
Figure 2.3(A) Orange Vapor Seen During SSME Ignition

Extensive orange vapor (possibly free burning hydrogen) was seen forward of the SSME rims, contacting the drag chute door, and extending forward along the base of the vertical stabilizer during SSME ignition (10:11:04.7 UTC). See Figure 2.3(A). Orange vapor forward of the SSME rims has been seen on previous mission films and videos. However, the orange vapor seen on STS-101 was more apparent than the vapors seen on most previous missions. (Cameras OTV051, OTV070, E1, E2, E5, E17, E18, E19, E20, E63, E76)

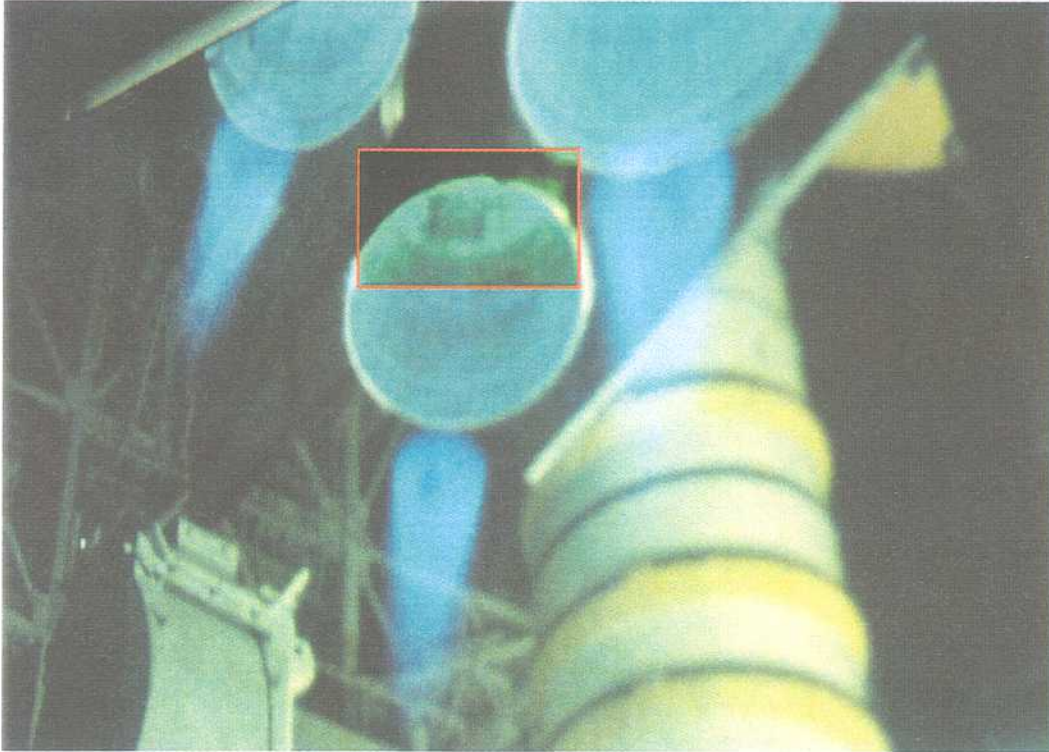
Figure 2.4(A) White-colored Ring Seen inside SSME #2

A white-colored ring was visible on the hot wall inside of the SSME #2 nozzle at liftoff (10:11:11.732 UTC) and during ascent (10:12:22.5 UTC). See Figure 2.4(A). MSFC reported that the SSME #2 hot wall appeared normal on the camera E19 liftoff view. No follow-up action was requested. (Cameras E19, E207, ET207)

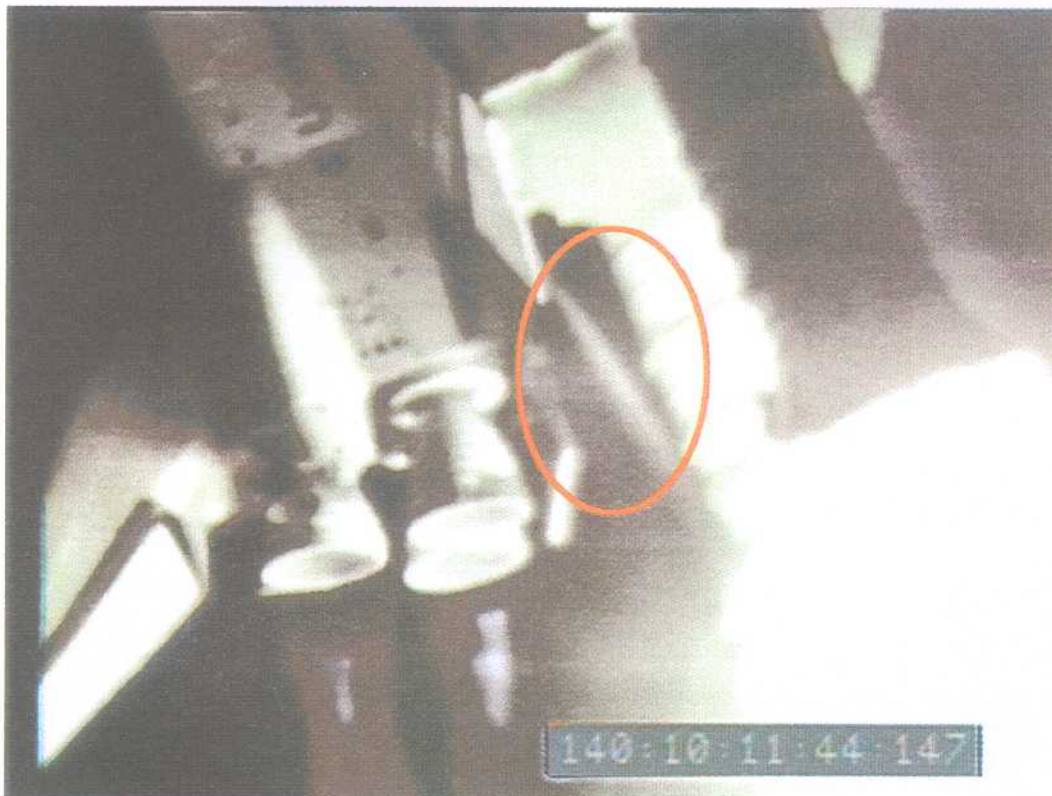
Figure 2.4(B) STS-101 Streak Seen off Starboard Elevon

On STS-101 ascent, a long white-colored vaporous streak was seen trailing from the right inboard elevon after the roll maneuver at approximately 34 seconds MET (10:11:44.15 UTC). See Figure 2.4(B). Figure 2.4(C) contains a comparison between a similar, but more extensive, streak seen on STS-26R with the streak seen on STS-101. (The streak on STS-26R occurred at approximately 51 seconds MET.) Prior to the STS-101 landing, the MER manager was provided with a summary of the previous Space Shuttle flights with known launch events that could possibly be associated with Orbiter tile damage.

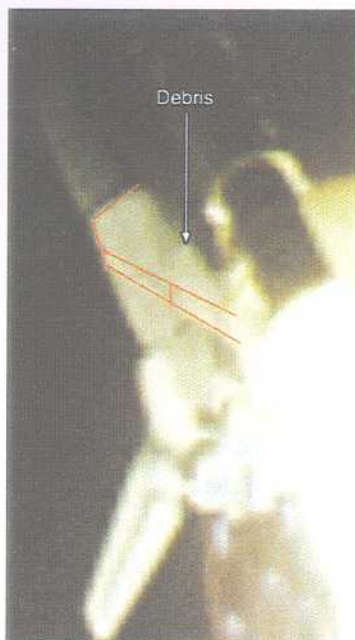
Figure 2.4(D) Possible Debris Contacting Right Wing

On STS-101 camera film E224 (Figure 2.4(D)), a white-colored object appeared to (possibly) contact the undersurface of the right wing (outlined in red) immediately prior to the time that the streak was visible on the camera ET207 view shown in Figure 2.4(B). (10:11:44.109 UTC). (Cameras ET207, E207, E224)

Post landing inspections confirmed that tile damage to the underside of the right wing, previously suspected because of the imagery screening, had occurred. However KSC reported that this damage was not a significant concern. The impact site was located about 10 feet in front of the right inboard elevon and measured 5.25-inches long, 1.5-inches wide and 0.5-inch deep. (As a comparison, STS-26R tile damage measured during the post landing inspection was 18 x 6 inches in area and extended 1.5 inches into the upper surface of the right wing). On STS-101, there was no indication of structural damage.

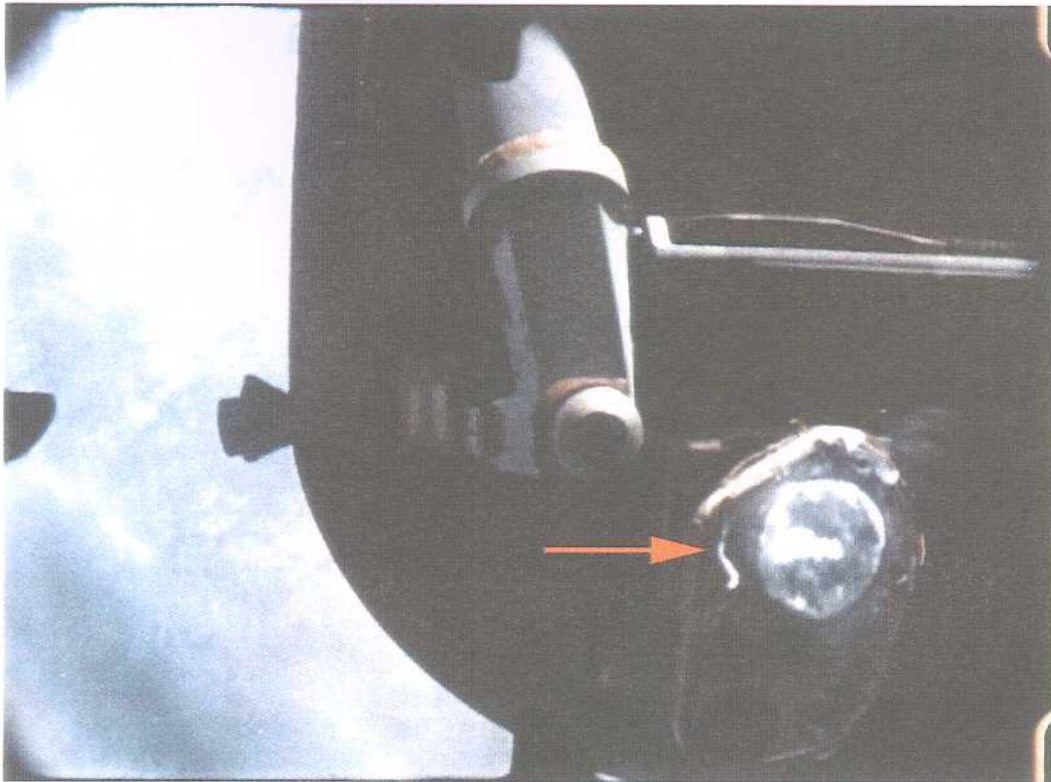
Figure 2.5.1(A) Detached Purge Seal on Face of LH2 Umbilical

Most of the face of the ET/Orbiter LH2 umbilical was obscured by shadows during the separation of the ET from the Orbiter. However, a forward outboard portion (~9 o'clock position on the face of the LH2 umbilical) of the white-colored purge seal was seen to be partially detached and extending outward toward the camera (+Z direction). See Figure 2.5.1(A). As typically seen on previous missions, frozen hydrogen was visible on the orifice of the LH2 17 inch connect and near the 1 o'clock position of the LH2 umbilical and the -Y end of the ET cross beam. The red-colored purge seal on the EO-2 ball joint fitting appeared to be in place.

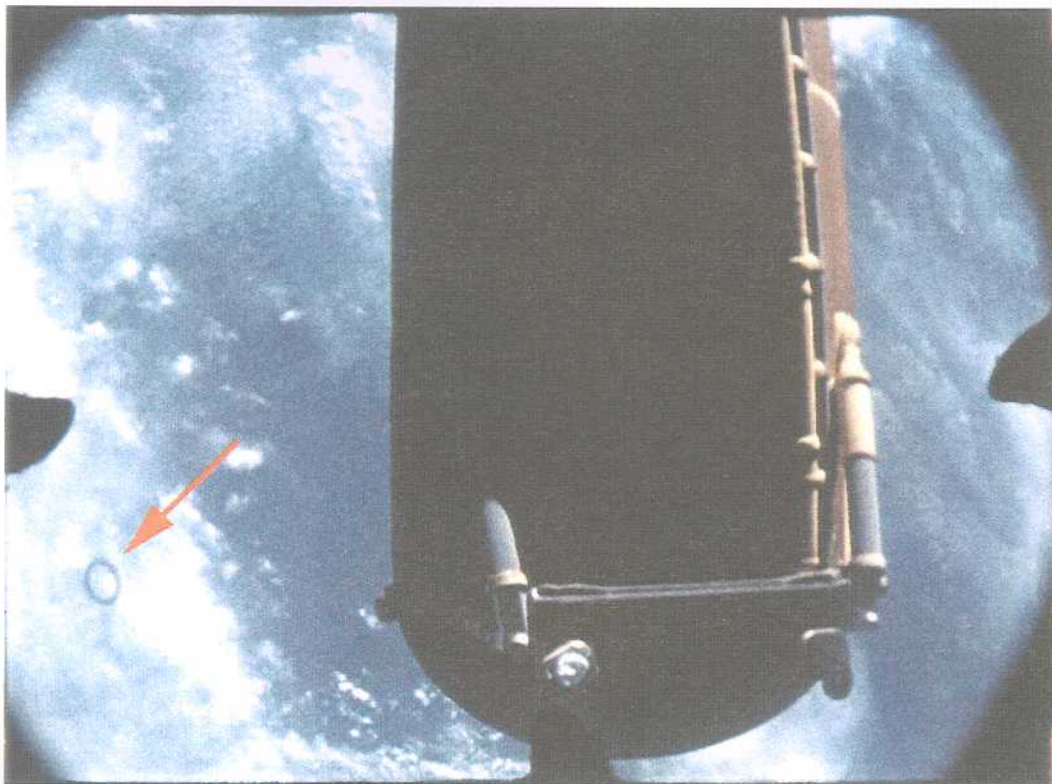
Figure 2.5.1(B) Unidentified Debris

On frames 7819 through 7900, a circular-shaped debris object was seen tumbling aft along the left side of the field of view. See Figure 2.5.1(B). The object appeared close to the camera and had a large inner diameter. KSC reported that the object might be an O-ring rather than a washer.

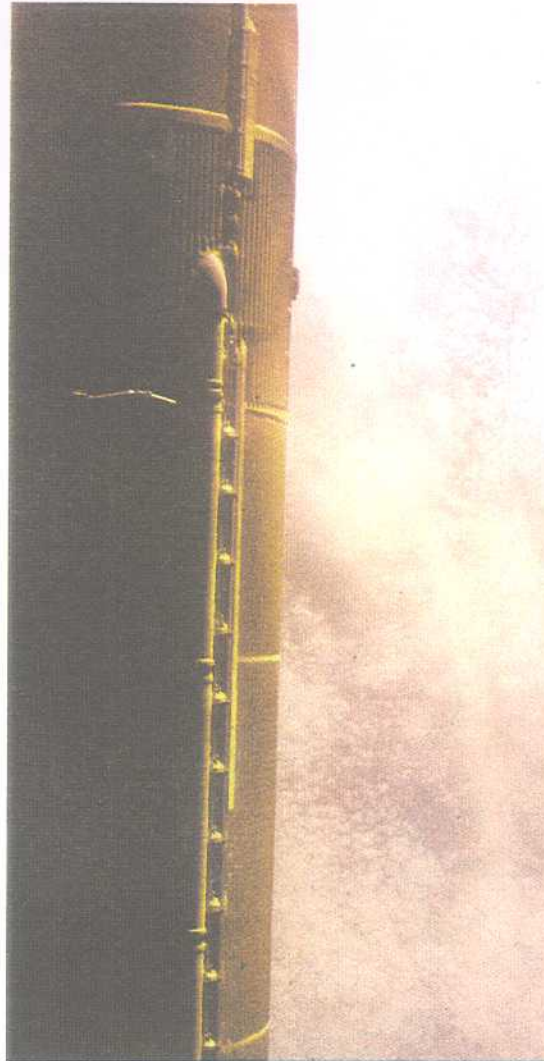
Figure 2.5.1(C) +Z/+Y ET Intertank

The un-shadowed, visible portion of the +Z/+Y LH2 tank TPS appeared to be in excellent condition. A possible area of minor LH2 tank TPS erosion was seen in the +Y direction from the +Y longeron at approximately station XT-1900 that was not visible on the pre-launch closeout photography. However, the color and tone of these marks is similar to

older pre-launch repair marks indicating that no additional TPS coating was lost during ascent.

The visible portion of the +Z/+Y ET Thrust Panel appeared in excellent condition. No divots were noted on the rib heads of the +Y ET thrust panel TPS. As expected, the left (-Y) SRB thrust panel was not imaged on this film.

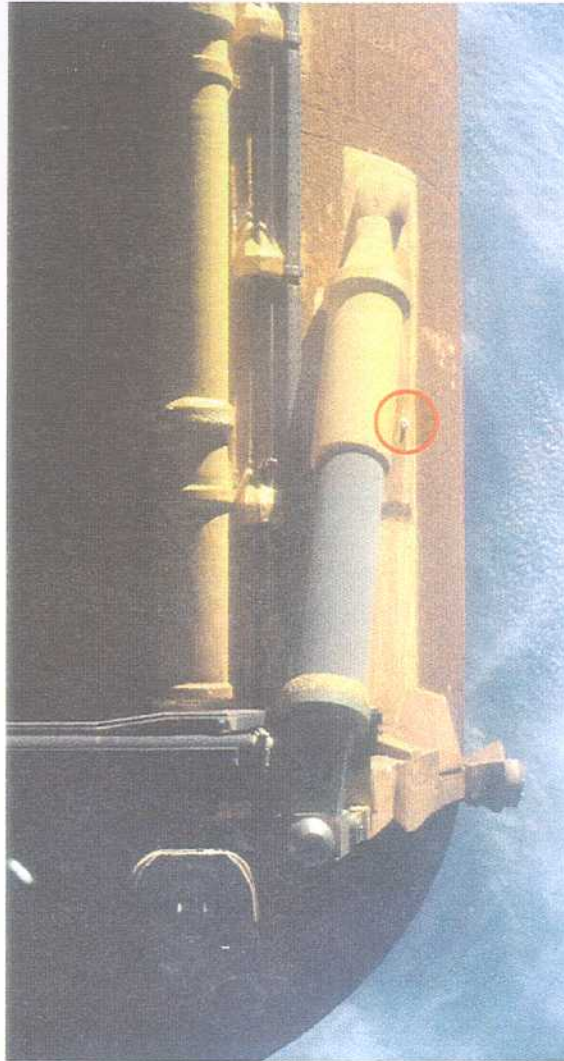
Figure 2.5.1(D) White-colored Object on +Y Longeron

A small, square-shaped, white-colored object that appears to be ice / frost or possibly a piece of up-lifted TPS was seen near the mid level of the +Y longeron at approximately station XT-1980. See Figure 2.5.1(D). KSC reported that a hairline crack was noted on this area of the +Y longeron during cryo-loading.

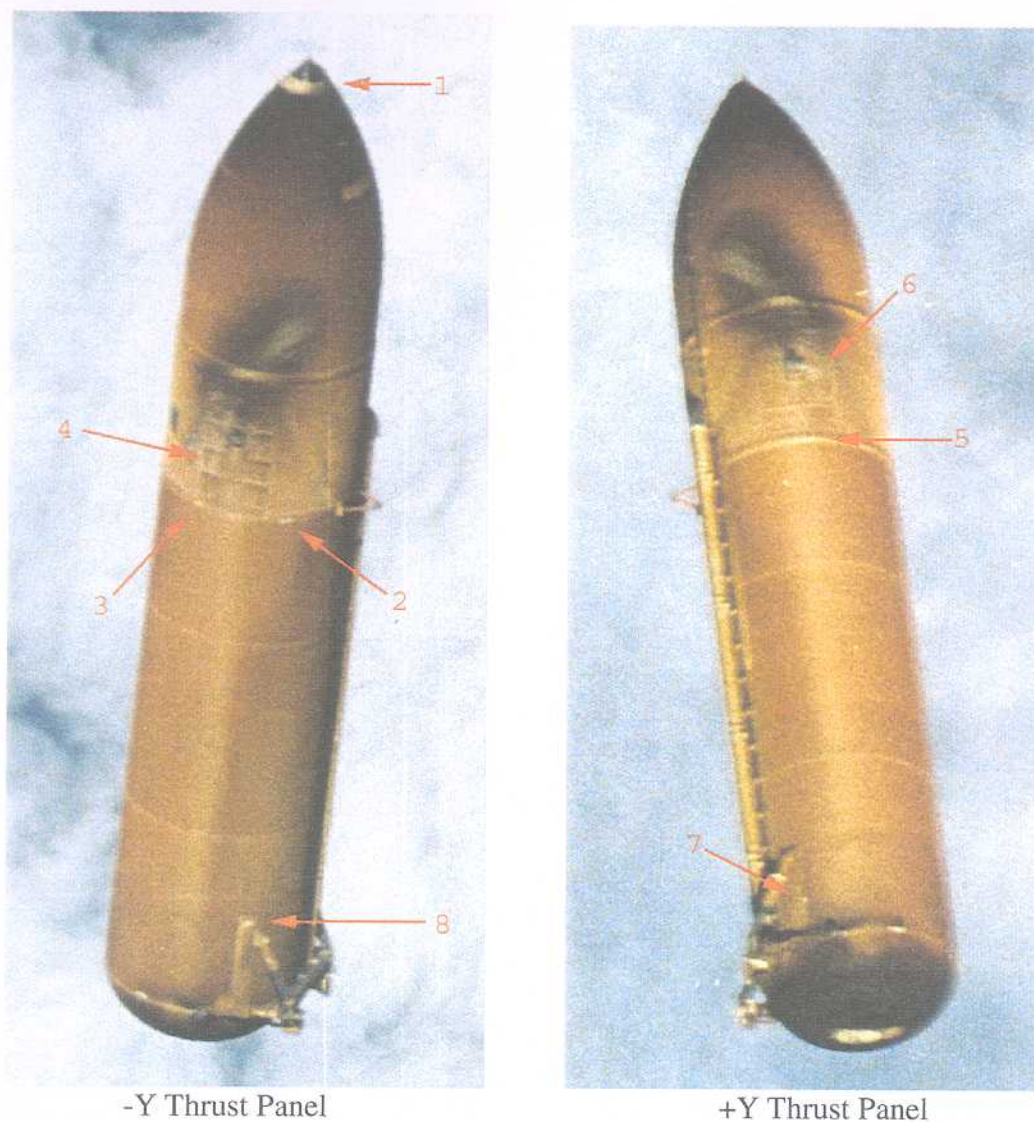
Figure 2.5.2(A) Handheld ET Views

The normal SRB separation burn scars and aero-heating marks were noted on the intertank and nose TPS of the ET. See Figure 2.5.2(A). In addition, the following items were noted:

- A band of eroded TPS (and possible divots) was seen just aft of the ET nose cap. (Figure 2.5.2(A) annotation #1)
- Two light-colored marks (divots), approximately 9-inches in diameter, are visible in the direction of the left (-Y) limb of the ET on the LH2 tank-to-intertank flange closeout between the bipod and the -Y thrust panel. (Figure 2.5.2(A) annotation #2)
- A light-colored mark (divot), approximately 9-inches in size was seen near the LH2 tank-to-intertank flange at the aft -Y corner of the -Y thrust panel. (Figure 2.5.2(A)

annotation #3) (On the LSRB thrust panel video, this divot appeared to be in the LH2 tank TPS adjacent to the flange close-out.)

- Three large appearing light-colored areas were noted on the -Y thrust panel in the -Y direction from the LSRB forward attach fitting. (On the LSRB thrust panel video, there is an indication of possible small divots on several rib heads in one of these three areas that could be seen during SRB separation.) (Figure 2.5.2(A) annotation #4)

- Two light-colored marks were detected on the +Y LH2 tank-to-intertank flange close out aft of the forward RSRB attach fitting. (Figure 2.5.2(A) annotation #5) This portion of the LH2 tank-to-intertank flange close out was imaged on the close-up RSRB thrust panel video during ET separation. However, no indication of TPS erosion or divots was seen on the close up video.

- Three light-colored areas were detected on the +Y thrust panel in the +Y direction from the RSRB forward attach fitting. These light-colored areas may be caused by areas of TPS erosion or clusters of divots too small to resolve on the handheld film. (Figure 2.5.2(A) annotation #6)

- A light-colored mark (possible divot) was seen on the +Y longeron (Figure 2.5.2(A) annotation #7). This may be the white-colored object visible on the 35mm umbilical well camera film circled on Figure 2.5.1(D).

- A light-colored mark (possible divot) was seen on the forward left corner of the -Y longeron. (Figure 2.5.2(A) annotation #8)

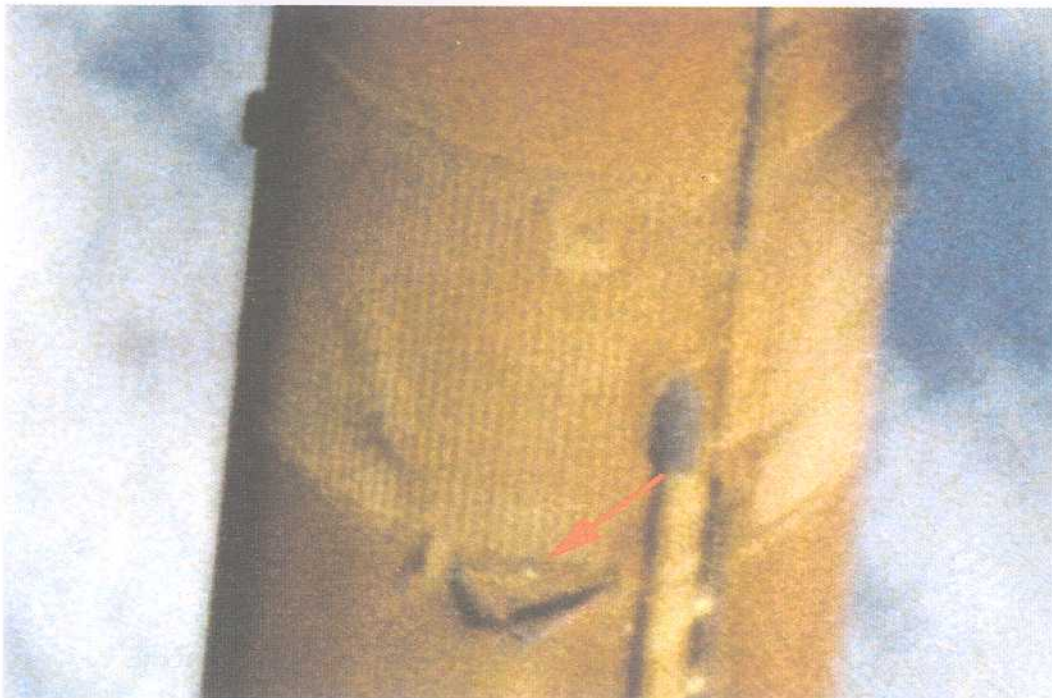
Figure 2.5.2(B) Handheld ET Views – Debris Seen between Legs of Forward Bipod

- A light-colored mark (divot), approximately 8 to 9-inches in size, is visible on the LH2 tank-to-intertank flange closeout between the legs of the forward bipod. (Figure 2.5.2(B))

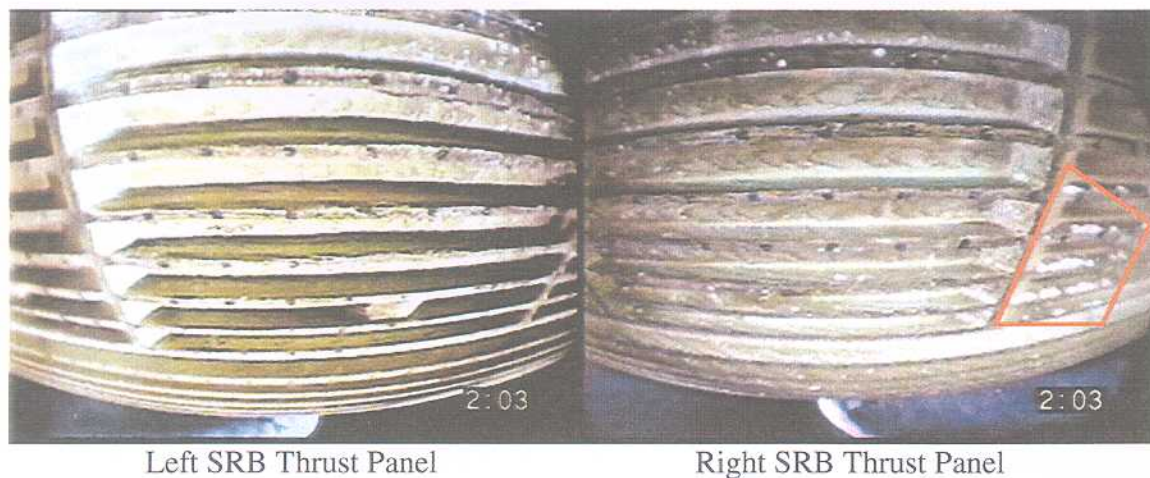
Figure 2.6 (A) ET Thrust Panel Views Prior to Separation

Figure 2.6(A) contains views of the STS-101 ET Thrust Panels just before SRB separation (2:03 seconds MET). After separation, there were a large number of divots visible in the unvented area of the right ET thrust panel aft and in the -Y direction from the RSRB attach fitting (area outlined in red on the right SRB thrust panel view). The largest of these divots were estimated to be less than 5-inches in diameter. Six divots were seen on a right thrust panel circumferential rib (station XT-1058). A seventh divot was seen on the same circumferential rib in the +Y direction closer to the +Y intertank.

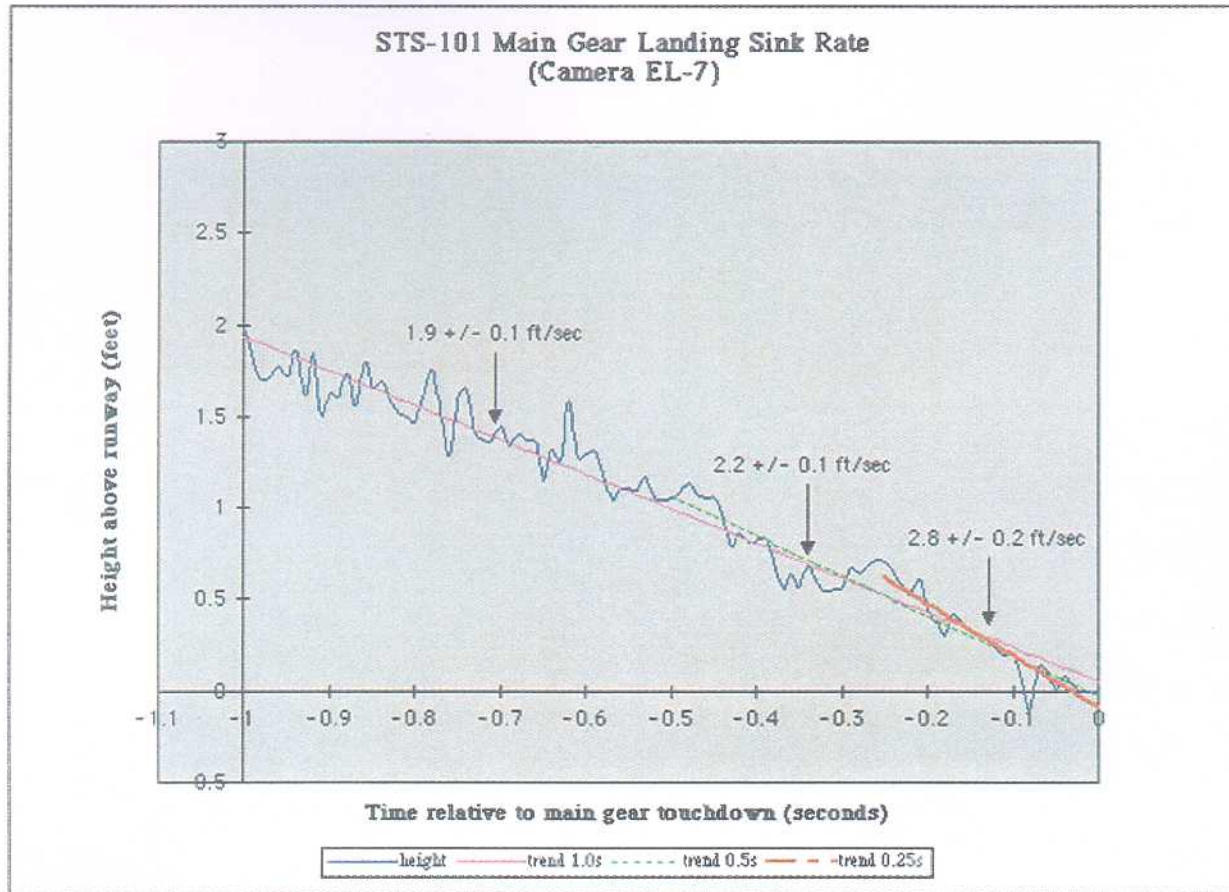
Figure 2.7 Main Gear Landing Sink Rate

The maximum allowable main gear sink rate values are 9.6 feet/second for a 212,000 lb. vehicle and 6.0 feet/second for a 240,000 lb. vehicle. The landing weight of the STS-101 vehicle was estimated to be 226,131 lbs.
